**Flood Control Project Maintenance
Levee Inspections**

Maintenance Issue Types Only, Levee Inspection Report By Mile - Spring 2016

Reclamation District No. 0150 Merrit Island

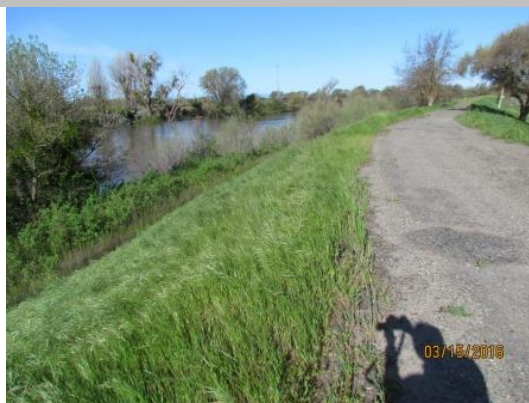
Photo 1 of 1 : SP_2016_RD0150_15_1_20160318_00004.jpg

View of the vegetation on the waterside slope of the levee.

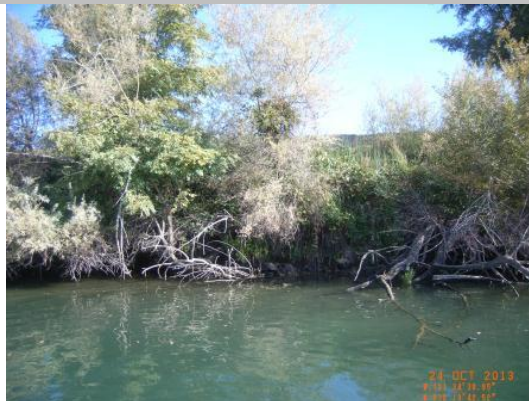
Photo 1 of 2 : SP_2016_RD0150_15_2_20160219_00001.jpg

LM Start	0.44	Rating **	M	Issue No.	2
LM End	0.49	Issue Type +	Ma	Location *	WS
Category	Supplemental			GPS Latitude/Longitude	
				Start	End
Item	2015 USACE Erosion Survey, DRAFT			38.328555 °	38.328020 °
				-121.577544 °	-121.576693 °
DWR ID	DWR_RD0150_01_s_2016_2				
Comment Code					
Inspector Comment					
2013 - Old toe repair unraveling. Bridge at upstream end of site. 2015: No observed changes. [2015 Site ID: STR_28-4_R]

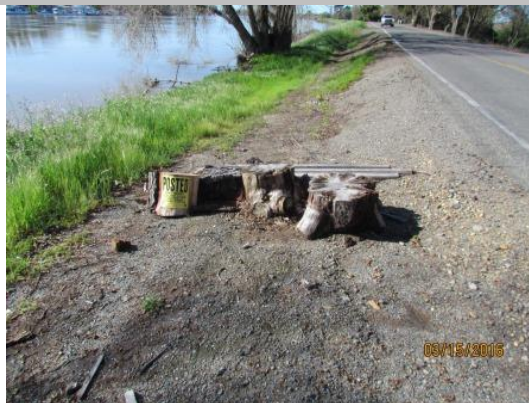
Photo 1 of 1 : SP_2016_RD0150_16_57_20160318_00114.jpg

View of tree stumps on the waterside shoulder of the levee looking downstream.

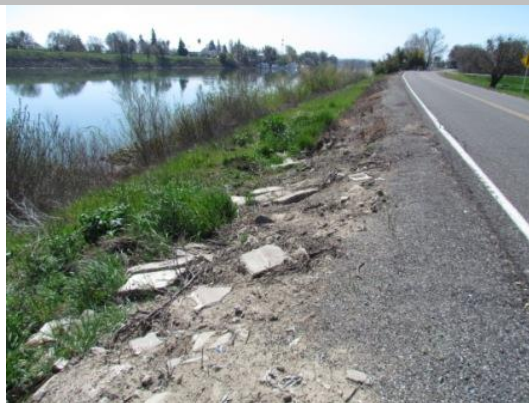
Photo 1 of 1 : SP_2016_RD0150_16_10_20160219_00006.jpg

Debris was found on the waterside slope of the levee looking downstream during Spring 2013 inspection.

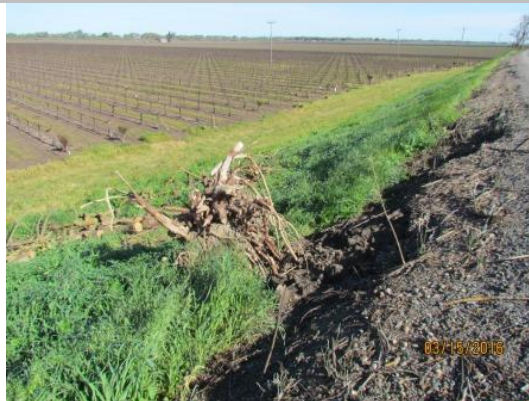
Photo 1 of 1 : SP_2016_RD0150_16_59_20160318_00115.jpg

LM Start	0.71	Rating **	M	Issue No.	59
LM End	0.71	Issue Type +	Ma	Location *	LS
Category	Earthen Levee			GPS Latitude/Longitude	
				Start	End
Item	Encroachments			38.336291 °	38.336291 °
				-121.568260 °	-121.568260 °
DWR ID	DWR_RD0150_02_s_2016_59				
Comment Code					
TR : Tree or limb					
Inspector Comment					
Damaged tree roots and trunks appear to damage landside slope of the levee.

View of tree trunks and roots on the landside of the levee looking upstream.

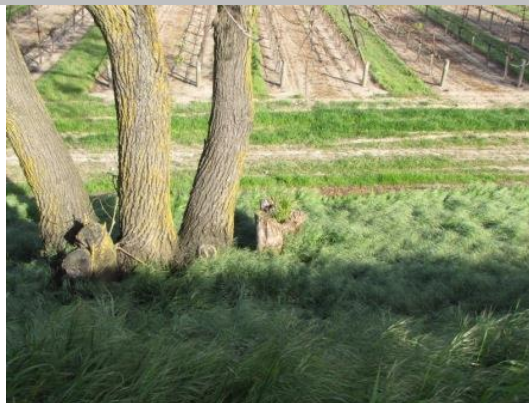
Photo 1 of 1 : SP_2016_RD0150_16_8_20160219_00004.jpg

View of a tree stump on the landward slope.

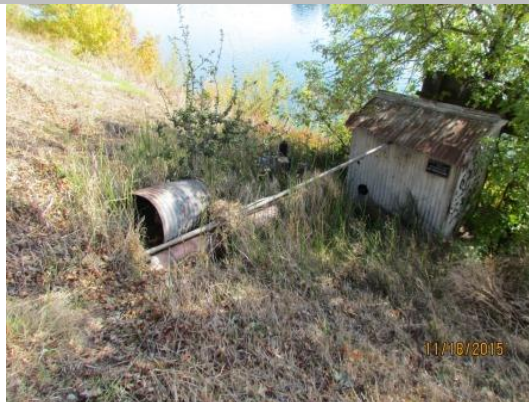
Photo 1 of 1 : SP_2016_RD0150_16_53_20160219_00028.jpg

LM Start	1.56	Rating **	M	Issue No.	53
LM End	1.56	Issue Type +	Ma	Location *	WS
Category	Earthen Levee			GPS Latitude/Longitude	
				Start	End
Item	Encroachments			38.344881 °	38.344881 °
				-121.557524 °	-121.557524 °
DWR ID	DWR_RD0150_02_f_2015_53				
Comment Code					
PI : Pipe					
Inspector Comment					
Abandoned pipes were found on the waterside slope.

Abandon pipes and debris was found on the waterside of the levee.

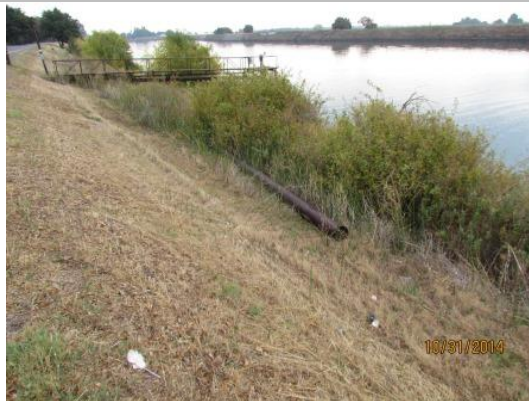
Photo 1 of 1 : SP_2016_RD0150_16_50_20160219_00027.jpg

LM Start	1.89	Rating **	M	Issue No.	50
LM End	1.89	Issue Type +	Ma	Location *	WS
Category	Earthen Levee			GPS Latitude/Longitude	
				Start	End
Item	Encroachments			38.346323 °	38.346323 °
				-121.551568 °	-121.551568 °
DWR ID	DWR_RD0150_02_f_2014_50				
Comment Code					
PI : Pipe					
Inspector Comment					
An abandoned pipe was found on the waterside of the levee.

A pipe was found on the waterside toe of the levee looking upstream.

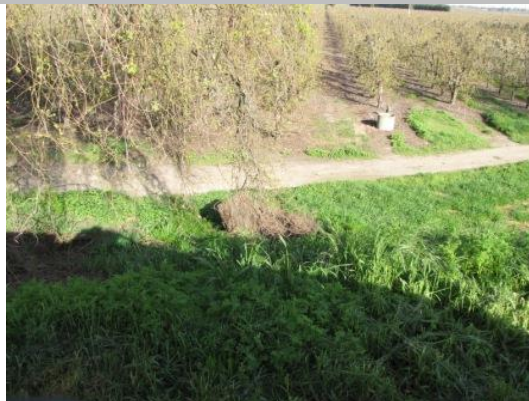
Photo 1 of 1 : SP_2016_RD0150_16_14_20160219_00009.jpg

View of a tree stump on the landward slope.

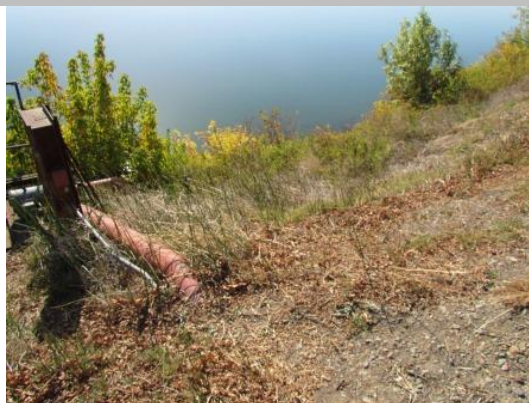
Photo 2 of 5 : SP_2016_RD0150_16_961_20160219_00048.jpg

LM Start	3.24	Rating **	M	Issue No.	961
LM End	3.24	Issue Type +	Ma	Location *	WS
Category	Earthen Levee			GPS Latitude/Longitude	
				Start	End
Item	Erosion / Bank Caving			38.355321 °	38.355321 °
				-121.530902 °	-121.530902 °
DWR ID	DWR_RD0150_02_s _ 2012_961				
Comment Code					
E2 : Schedule repair of erosion site prior to the next inspection.					
Inspector Comment					
Depressions into the waterward slope can be seen along the waterward slope at this site. Also note the damaged pump support, pump, and pipe just upstream of the site; they may contribute to the erosion in a high water event and should be removed.

View of the erosion on the waterside slope of the levee near the pipe looking downstream. This picture was taken during the fall 2013 inspection.

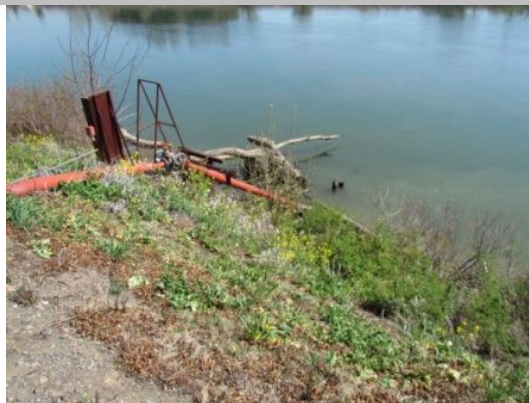
Photo 3 of 5 : SP_2016_RD0150_16_961_20160219_00049.jpg

LM Start	3.24	Rating **	M	Issue No.	961 (cont)
LM End	3.24	Issue Type +	Ma	Location *	WS
Category	Earthen Levee			GPS Latitude/Longitude	
				Start	End
Item	Erosion / Bank Caving			38.355321 °	38.355321 °
				-121.530902 °	-121.530902 °
DWR ID	DWR_RD0150_02_s_2012_961				
Comment Code					
E2 : Schedule repair of erosion site prior to the next inspection.					
Inspector Comment					
Depressions into the waterward slope can be seen along the waterward slope at this site. Also note the damaged pump support, pump, and pipe just upstream of the site; they may contribute to the erosion in a high water event and should be removed.

View of the erosion on the waterside slope of the levee looking upstream during spring 2013 inspection.

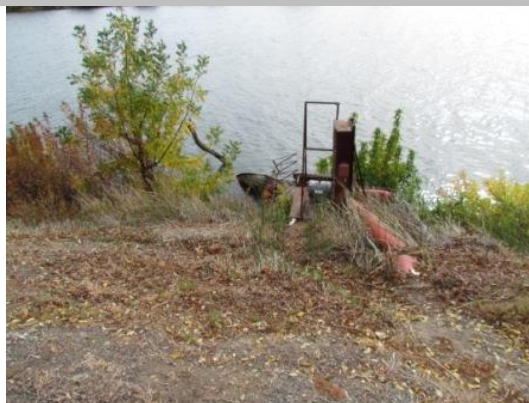
Photo 4 of 5 : SP_2016_RD0150_16_961_20160219_00050.jpg

View of erosion and damaged pipe and abandoned boat on the waterside of the levee looking upstream. This picture was taken during fall 2012 inspection.

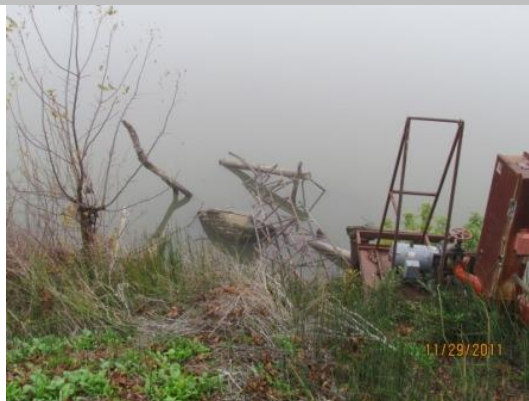
Photo 5 of 5 : SP_2016_RD0150_16_961_20160219_00051.jpg

LM Start	3.24	Rating **	M	Issue No.	961 (cont)	
LM End	3.24	Issue Type +	Ma	Location *	WS	
Category	Earthen Levee			GPS Latitude/Longitude		
				Start		End
Item	Erosion / Bank Caving			38.355321 °		38.355321 °
				-121.530902 °		-121.530902 °
DWR ID	DWR_RD0150_02_s _ 2012_961					
Comment Code						
E2 : Schedule repair of erosion site prior to the next inspection.						
Inspector Comment						
Depressions into the waterward slope can be seen along the waterward slope at this site. Also note the damaged pump support, pump, and pipe just upstream of the site; they may contribute to the erosion in a high water event and should be removed.

View of the erosion site, and broken pump support along with a boat on the waterside of the levee. The picture was taken from the crown looking towards the toe of the levee during fall 2011 inspection.

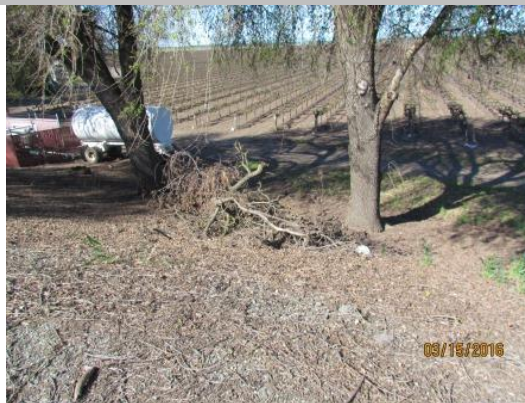
Photo 1 of 1 : SP_2016_RD0150_16_61_20160318_00116.jpg

View of prunings on the landside of the levee.

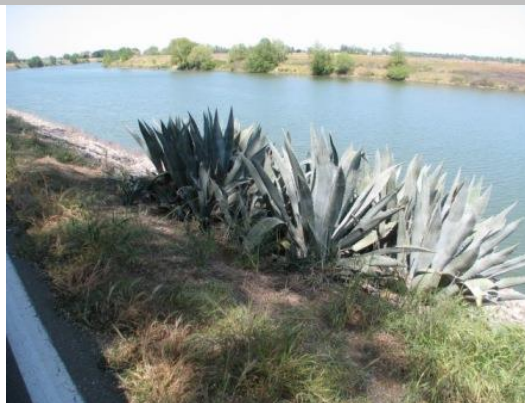
Photo 1 of 1 : SP_2016_RD0150_16_28_20160219_00016.jpg

Century plant on waterward slope at LM 4.76

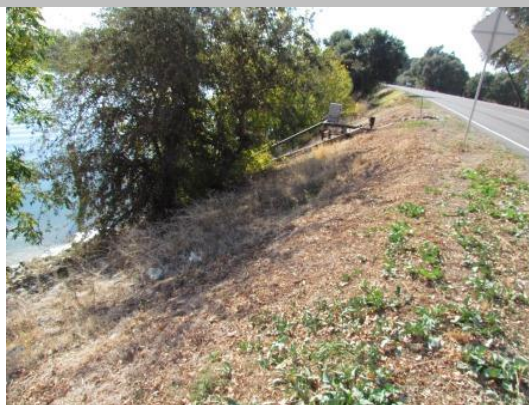
Photo 1 of 2 : SP_2016_RD0150_16_975_20160219_00052.jpg

LM Start	5.24	Rating **	M	Issue No.	975
LM End	5.24	Issue Type +	Ma	Location *	WS
Category	Earthen Levee			GPS Latitude/Longitude	
				Start	End
Item	Slope Stability			38.381126 °	38.381126 °
				-121.524207 °	-121.524207 °
DWR ID	DWR_RD0150_02_s_2013_975				
Comment Code					
S1 : Repair slope instability.					
Inspector Comment					
Depression in the waterward slope at the shoulder over an irrigation pipe.

View of minor slope instability on the waterside slope of the levee looking downstream during fall 2013 inspection.

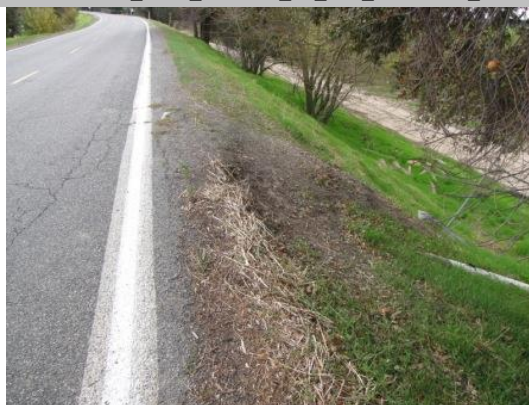
Photo 2 of 2 : SP_2016_RD0150_16_975_20160219_00053.jpg

View of a minor depression along the landward slope of the levee over a pipe penetration looking downstream.

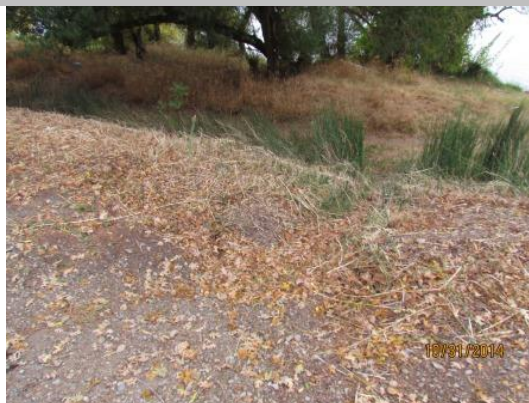
Photo 1 of 1 : SP_2016_RD0150_16_54_20160219_00029.jpg

LM Start	5.33	Rating **	M	Issue No.	54
LM End	5.33	Issue Type +	Ma	Location *	WS
Category	Earthen Levee			GPS Latitude/Longitude	
				Start	End
Item	Slope Stability			38.382072 °	38.382072 °
				-121.523220 °	-121.523220 °
DWR ID	DWR_RD0150_02_f_2014_54				
Comment Code					
S2 : Repair the levee slope damaged by foot traffic and prevent access where possible.					
Inspector Comment

View of a slope instability on the waterside of the levee looking towards the toe.

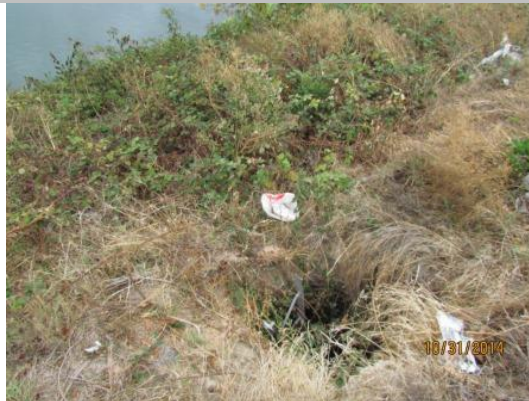
Photo 1 of 1 : SP_2016_RD0150_16_55_20160219_00030.jpg

An open pipe valve was found without a cover on the waterside toe of the levee.

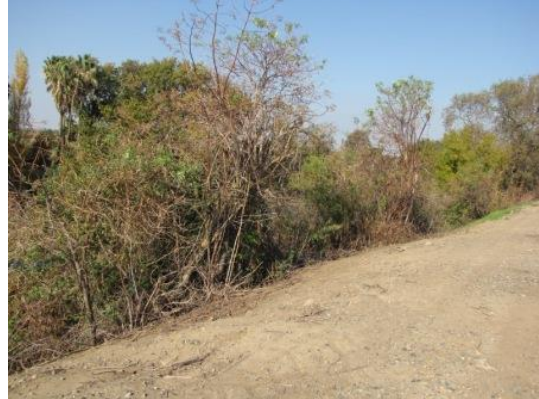
Photo 1 of 1 : SP_2016_RD0150_17_936_20160219_00097.jpg

View of elderberry bush within 20 feet of shoulder blocking visibility and access.

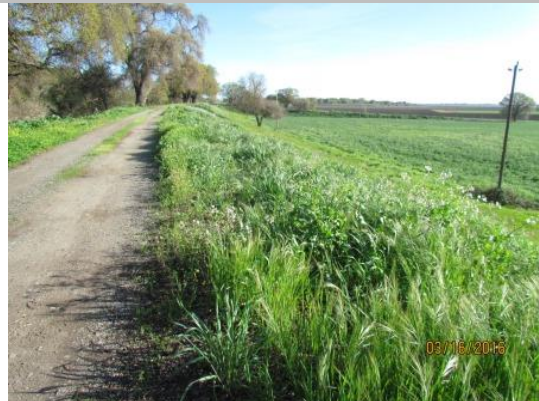
Photo 1 of 1 : SP_2016_RD0150_17_76_20160321_00142.jpg

View of the vegetation on the landside of the levee.

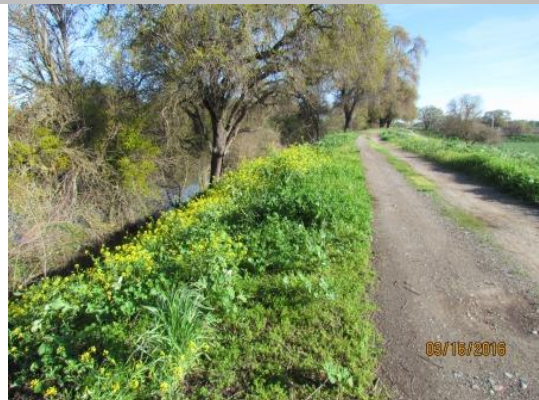
Photo 1 of 1 : SP_2016_RD0150_17_74_20160321_00143.jpg

View of the vegetation on the waterside of the levee.

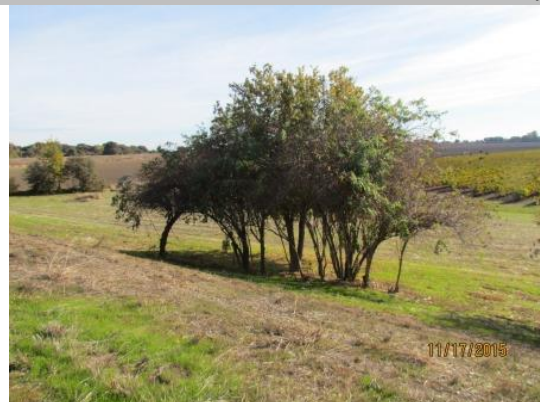
Photo 1 of 1 : SP_2016_RD0150_17_5_20160219_00005.jpg

View of elderberries on the landward slope of the levee.

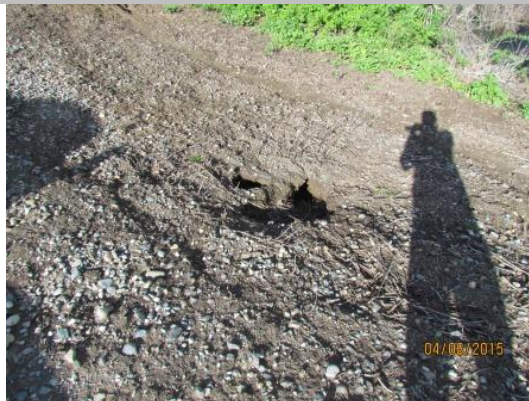
Photo 1 of 1 : SP_2016_RD0150_17_393_20160219_00091.jpg

Rodent holes were found on the waterside of the levee looking downstream.

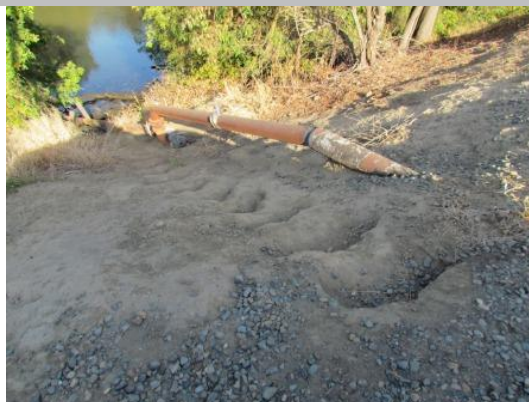
Photo 1 of 1 : SP_2016_RD0150_17_50_20160219_00043.jpg

Steps were dug next to the pipe and also erosion was found near the vicinity of the pipe on the waterside slope of the levee looking upstream.

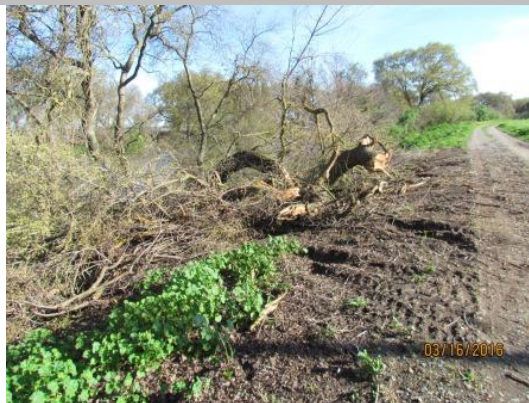
Photo 1 of 1 : SP_2016_RD0150_17_85_20160321_00144.jpg

View of broken tree trunk on the waterside slope of the levee.

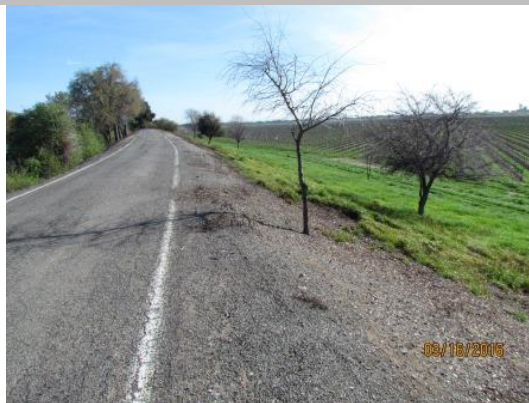
Photo 1 of 2 : SP_2016_RD0150_17_75_20160321_00145.jpg

LM Start	2.24	Rating **	M	Issue No.	75
LM End	2.24	Issue Type +	Ma	Location *	LS
Category	Earthen Levee			GPS Latitude/Longitude	
				Start	End
Item	Vegetation			38.353811 °	38.353811 °
				-121.565668 °	-121.565668 °
DWR ID	DWR_RD0150_03_f_2014_75				
Comment Code					
V2 : Remove the wild growth other than native grasses from the levee slopes.					
Inspector Comment					
Newly planted tree was found on the landside slope of the levee.

Updated picture of the newly planted tree on the landside shoulder of the levee during spring 2016.

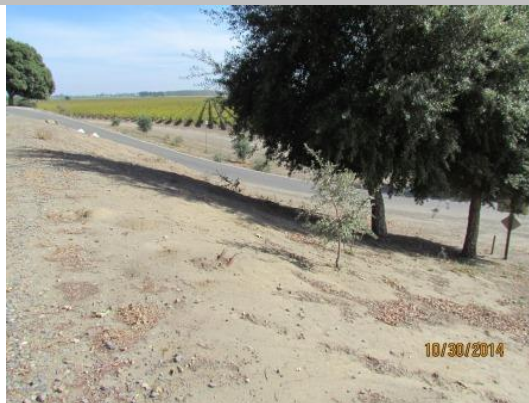
Photo 2 of 2 : SP_2016_RD0150_17_75_20160219_00069.jpg

View of a few trees that were planted on the landside slope of the levee looking upstream.

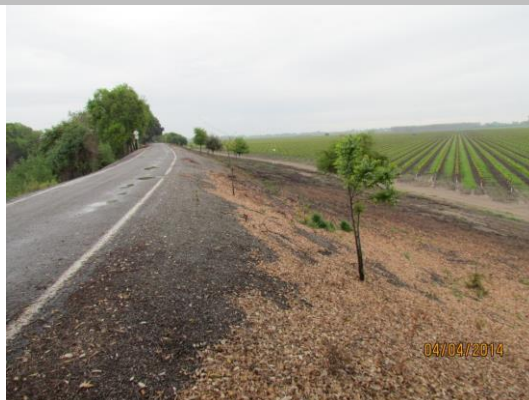
Photo 2 of 4 : SP_2016_RD0150_17_78_20160219_00072.jpg

View of the newly planted tree on the landside slope of the levee during spring 2014 inspection.

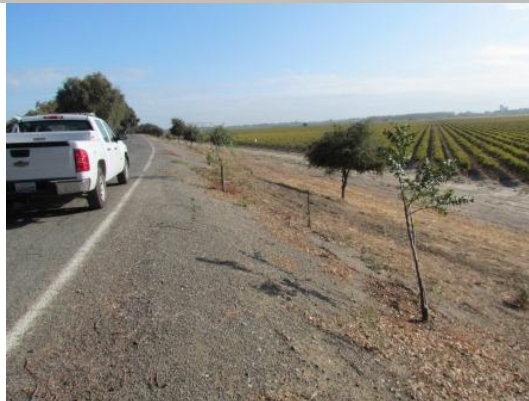
Photo 3 of 4 : SP_2016_RD0150_17_78_20160219_00073.jpg

Several newly planted trees were found on the landside slope of the levee looking upstream during the fall 2013 inspection.

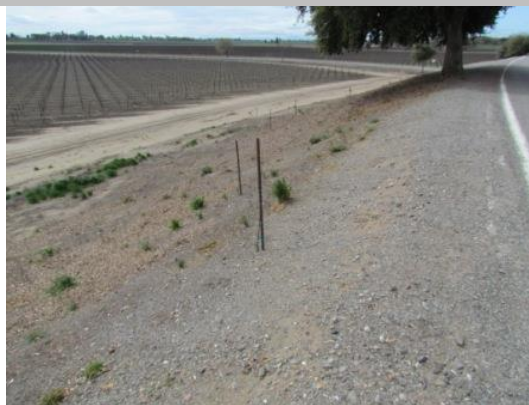
Photo 4 of 4 : SP_2016_RD0150_17_78_20160219_00074.jpg

New tree was planted on the landside of the levee looking downstream.

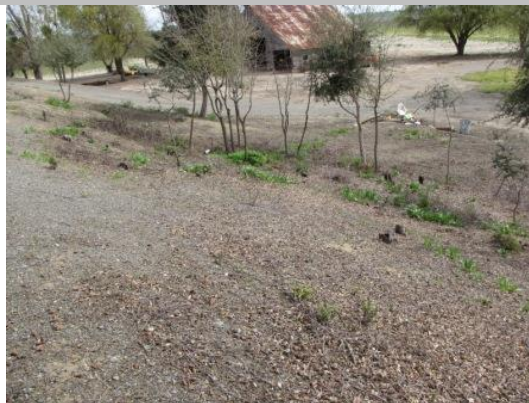
Photo 1 of 1 : SP_2016_RD0150_17_11_20160219_00008.jpg

View of tree stumps on the landward slope.

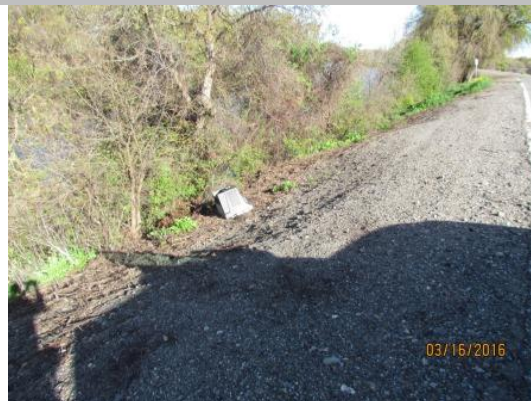
Photo 1 of 1 : SP_2016_RD0150_17_86_20160321_00146.jpg

View of the debris on the waterside slope of the levee.

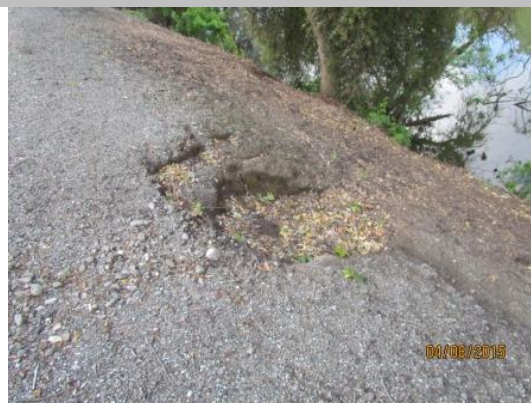
Photo 1 of 2 : SP_2016_RD0150_17_35_20160219_00028.jpg

Updated picture of the erosion on the waterside of the levee during spring 2015 inspection.

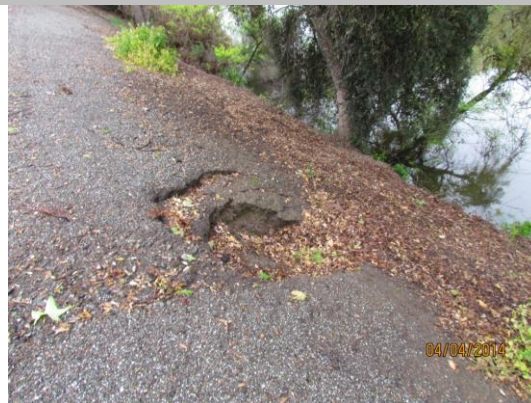
Photo 2 of 2 : SP_2016_RD0150_17_35_20160219_00029.jpg

Updated picture of the erosion on the waterside slope of the levee during spring 2014 inspection.

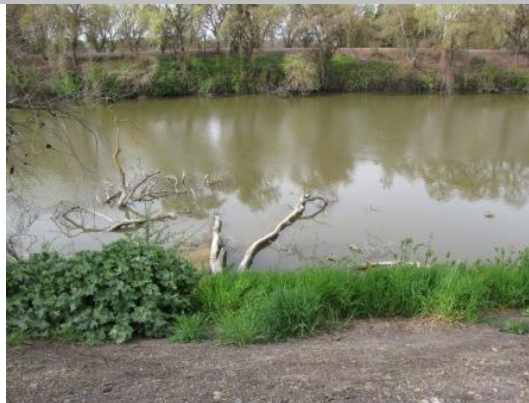
Photo 1 of 1 : SP_2016_RD0150_17_17_20160219_00015.jpg

View of tree stumps on the waterward slope.

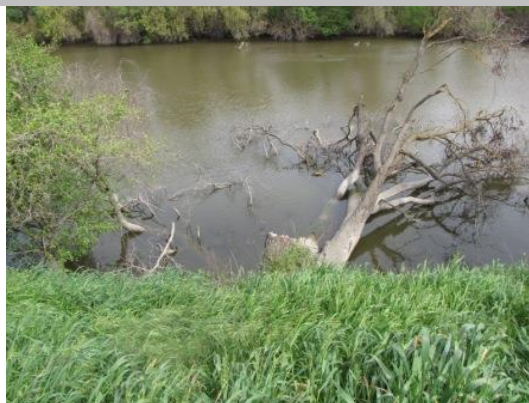
Photo 1 of 1 : SP_2016_RD0150_17_20_20160219_00016.jpg

View of tree stumps on the waterward slope.

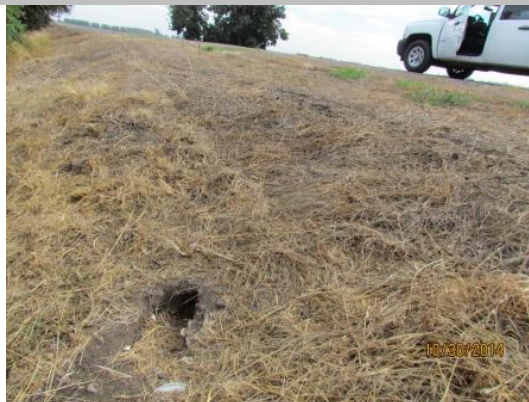
Photo 1 of 1 : SP_2016_RD0150_17_77_20160219_00070.jpg

A rodent hole was found on the waterside of the levee looking upstream.

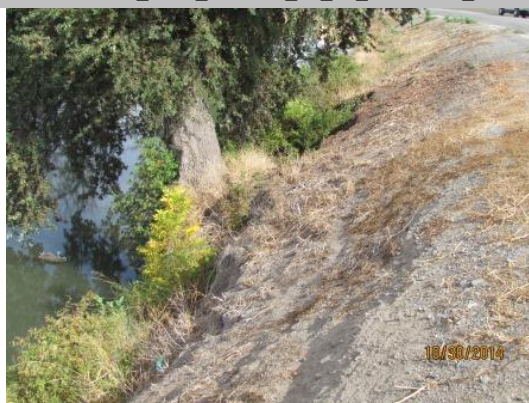
Photo 2 of 2 : SP_2016_RD0150_17_40_20160219_00034.jpg

Updated picture of the erosion on the waterside of the levee looking upstream during fall 2014 inspection.

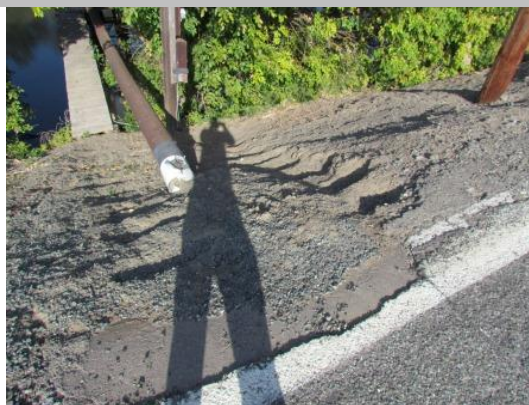
Photo 1 of 1 : SP_2016_RD0150_17_114_20160219_00087.jpg

View of steps that were dug on the waterside slope of the levee looking upstream.

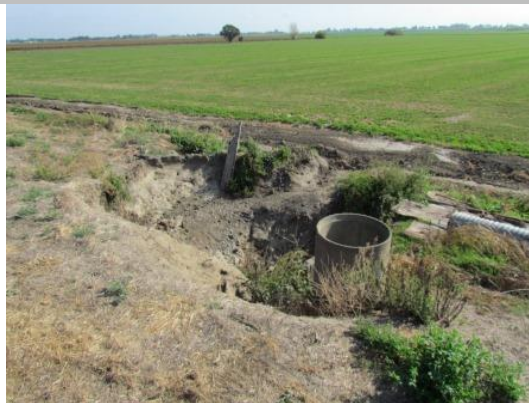
Photo 2 of 2 : SP_2016_RD0150_17_115_20160219_00089.jpg

A drainage ditch with depth of 4 feet and width of 15 feet was found on the landside toe of the levee. The picture was taken from the landside slope looking upstream during the fall 2013 inspection.

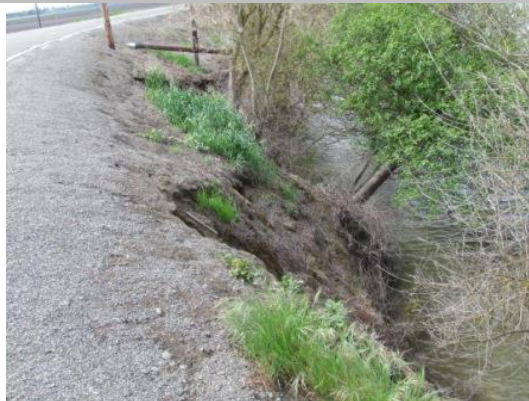
Photo 1 of 1 : SP_2016_RD0150_17_98_20160219_00086.jpg

Erosion was found on the waterside of the levee looking downstream.

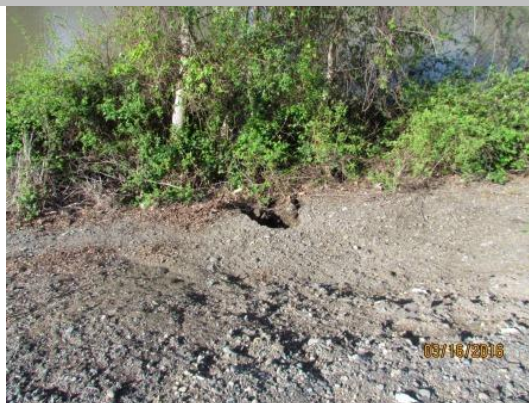
Photo 1 of 1 : SP_2016_RD0150_17_93_20160321_00147.jpg

An erosion was found on the waterside toe of the levee.

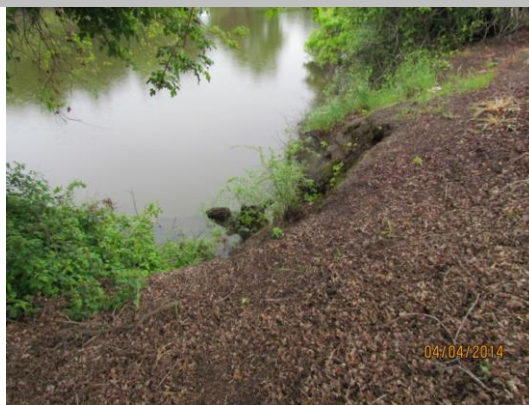
Photo 1 of 1 : SP_2016_RD0150_17_80_20160219_00075.jpg

View of an erosion site on the waterside toe of the levee looking upstream.

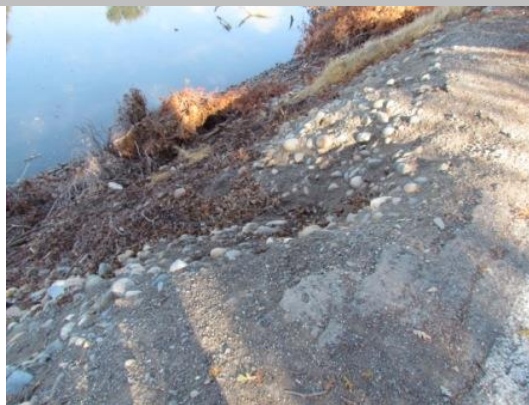
Photo 2 of 2 : SP_2016_RD0150_17_36_20160219_00031.jpg

Slope instability was found on the waterside of the levee looking upstream.

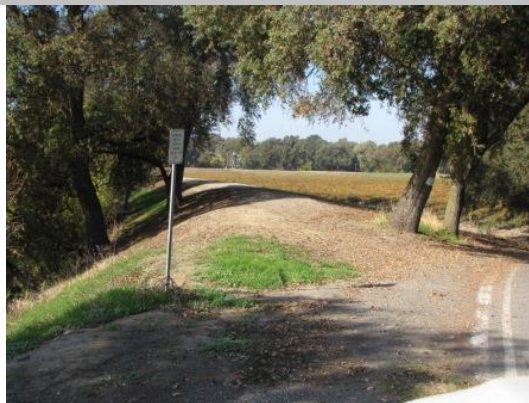
Photo 1 of 1 : SP_2016_RD0150_17_941_20160219_00098.jpg

View of varying elevations in the crown of the levee at the transition from county road to access road.

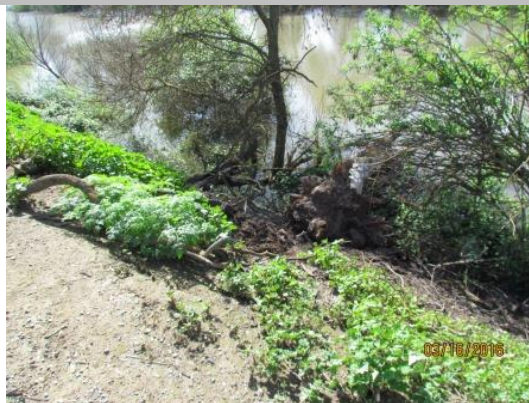
Photo 1 of 1 : SP_2016_RD0150_17_96_20160321_00149.jpg

Broken tree roots and tree trunks were found on the waterside toe of the levee.

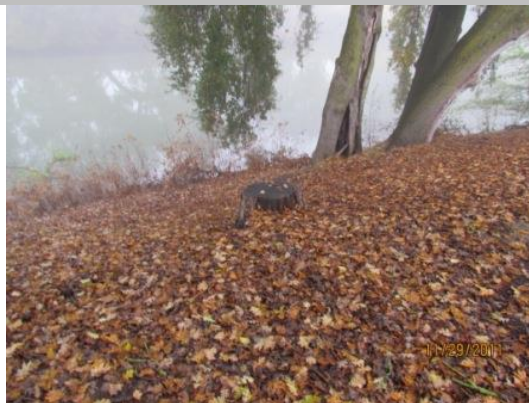
Photo 1 of 1 : SP_2016_RD0150_17_68_20160219_00067.jpg

Tree stump was found on the waterside of the levee looking upstream.

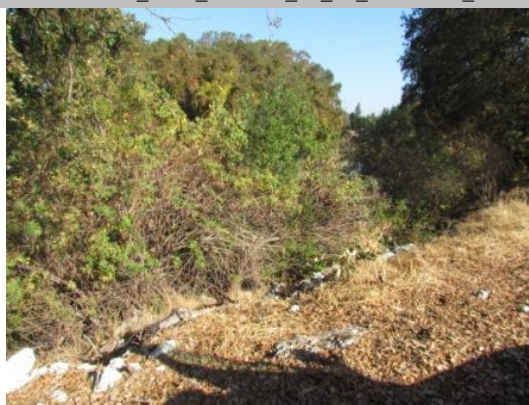
Photo 1 of 1 : SP_2016_RD0150_17_28_20160219_00021.jpg

Wild growth was found on the waterside slope of the levee looking upstream.

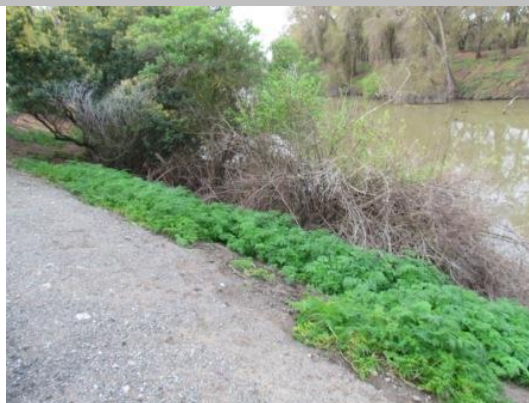
Photo 1 of 1 : SP_2016_RD0150_17_33_20160219_00026.jpg

Tree trunks and vegetation was obstructing the visibility on the waterside slope of the levee looking downstream.

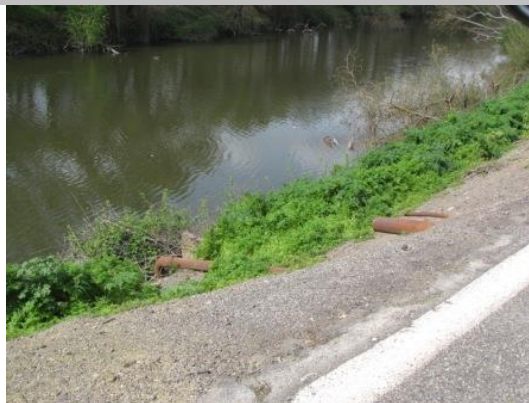
Photo 1 of 1 : SP_2016_RD0150_17_46_20160219_00039.jpg

View of an improperly abandoned pipe through the levee looking upstream.

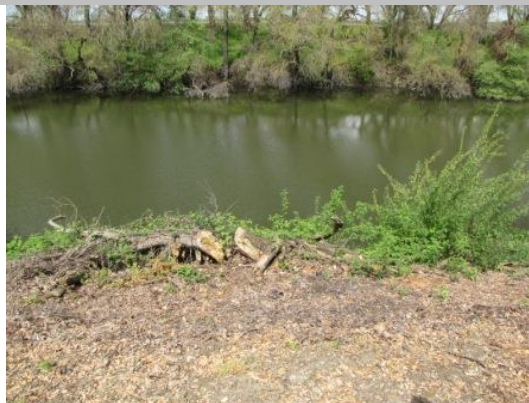
Photo 1 of 1 : SP_2016_RD0150_17_49_20160219_00042.jpg

View of tree stumps on the waterward slope.

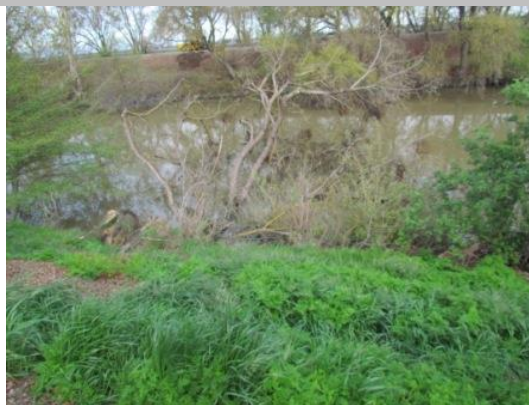
Photo 2 of 2 : SP_2016_RD0150_17_62_20160219_00060.jpg

Vegetation on the waterside of the levee looking downstream.

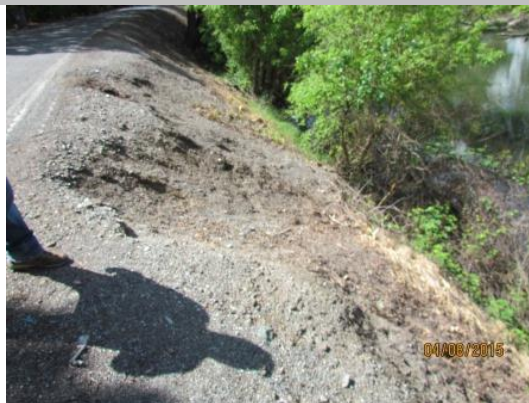
Photo 1 of 2 : SP_2016_RD0150_17_61_20160219_00057.jpg

Updated picture of the erosion on the waterside of the levee during spring 2015 inspection.

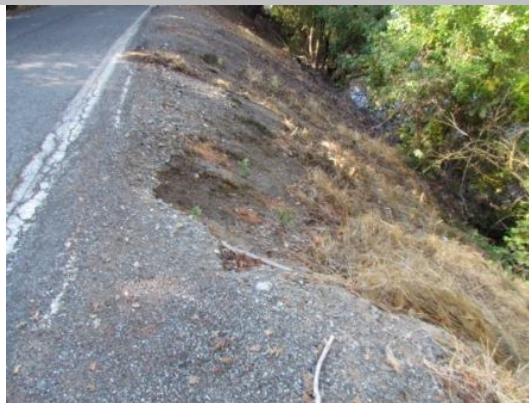
Photo 2 of 2 : SP_2016_RD0150_17_61_20160219_00058.jpg

Erosion was found on the waterside slope of the levee looking downstream. This updated picture was taken during fall 2012 inspection.

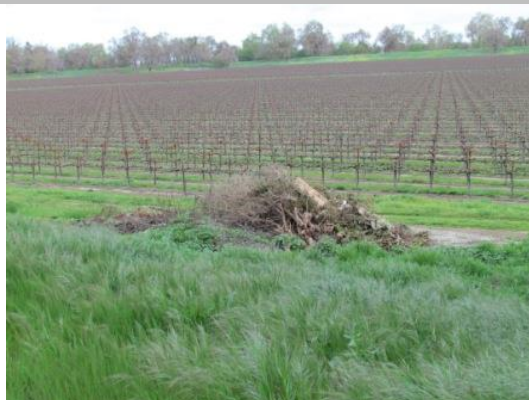
Photo 1 of 2 : SP_2016_RD0150_17_935_20160219_00095.jpg

Prunings were found on the landside of the levee looking upstream.

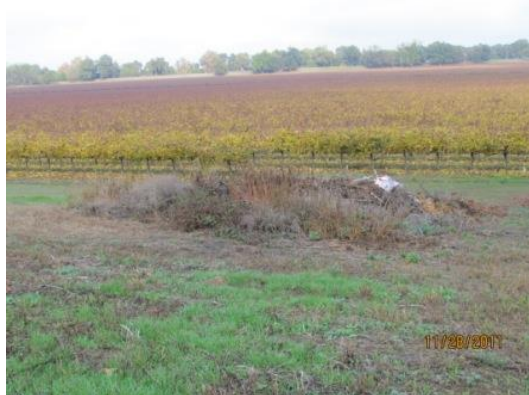
Photo 2 of 2 : SP_2016_RD0150_17_935_20160219_00096.jpg

Prunings were found on the landside of the levee looking upstream. This picture was taken during fall 2011 inspection.

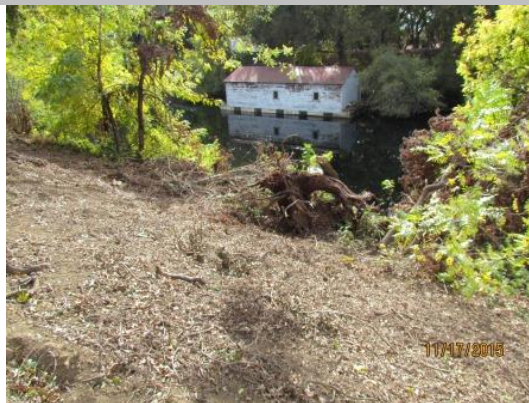
Photo 1 of 1 : SP_2016_RD0150_17_52_20160219_00048.jpg

View of the tree trunk on the waterside toe of the levee.

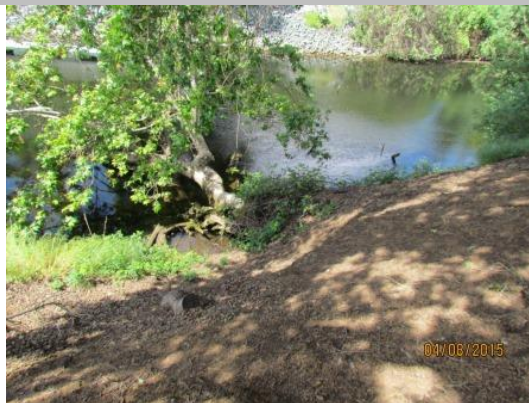
Photo 1 of 1 : SP_2016_RD0150_17_396_20160219_00092.jpg

Slope instability was found on the waterside toe of the levee looking upstream.

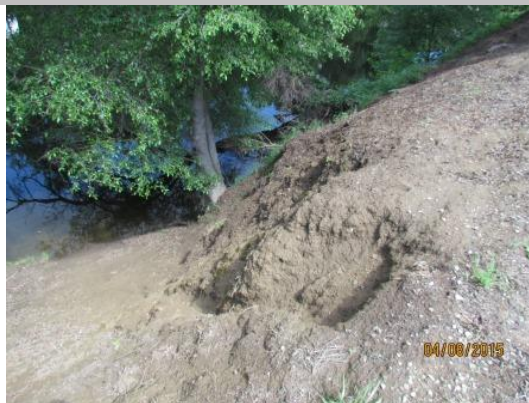
Photo 1 of 2 : SP_2016_RD0150_17_92_20160219_00084.jpg

Updated picture of the slope instability on the waterside of the levee looking upstream during spring 2015 inspection.

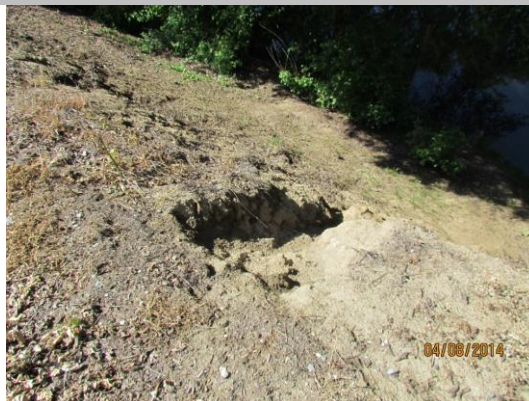
Photo 2 of 2 : SP_2016_RD0150_17_92_20160219_00085.jpg

A slope instability was found on the waterside of the levee looking downstream.

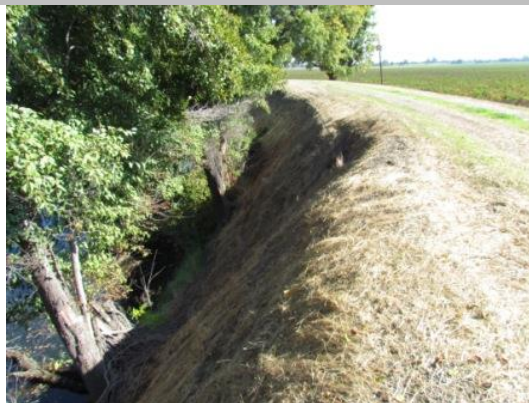
Photo 2 of 2 : SP_2016_RD0150_17_67_20160219_00066.jpg

Erosion was found on the waterside shoulder of the levee looking upstream. This picture was taken during fall 2012 inspection.

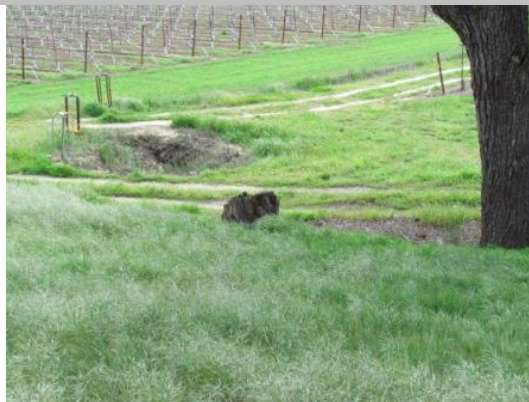
Photo 1 of 1 : SP_2016_RD0150_17_90_20160219_00083.jpg

A tree stump was found on the landside of the levee looking upstream.

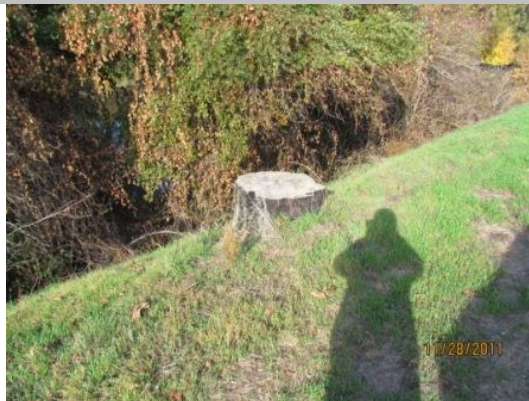
Photo 1 of 1 : SP_2016_RD0150_17_55_20160219_00051.jpg

A tree stump was found on the waterside of the levee looking upstream.

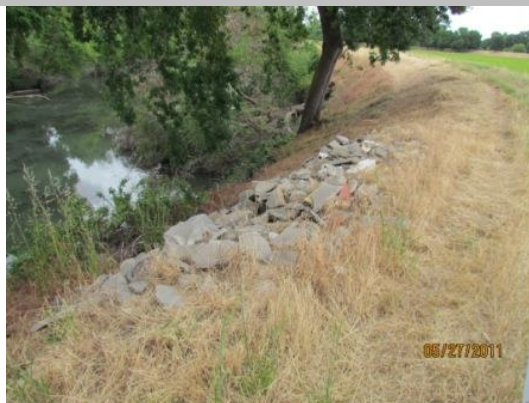
Photo 1 of 1 : SP_2016_RD0150_17_7_20160219_00006.jpg

Broken concrete pipe was left on the waterside slope of the levee. The picture was taken from the crown looking upstream.

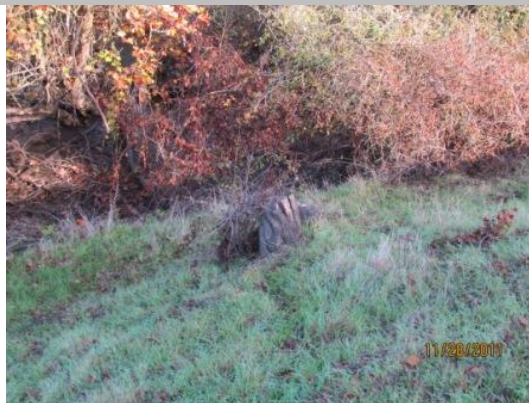
Photo 1 of 1 : SP_2016_RD0150_17_59_20160219_00055.jpg

A tree stump was found on the waterside of the levee looking upstream.
